UNDERWATER BRIDGE INSPECTION REPORT

STRUCTURE NO. 84505
CSAH NO. 14
OVER THE
OTTER TAIL RIVER
DISTRICT 4 - WILKIN COUNTY

PREPARED FOR THE
MINNESOTA DEPARTMENT OF TRANSPORTATION
BY
COLLINS ENGINEERS, INC.
JOB NO. 5221 (CEI 58)

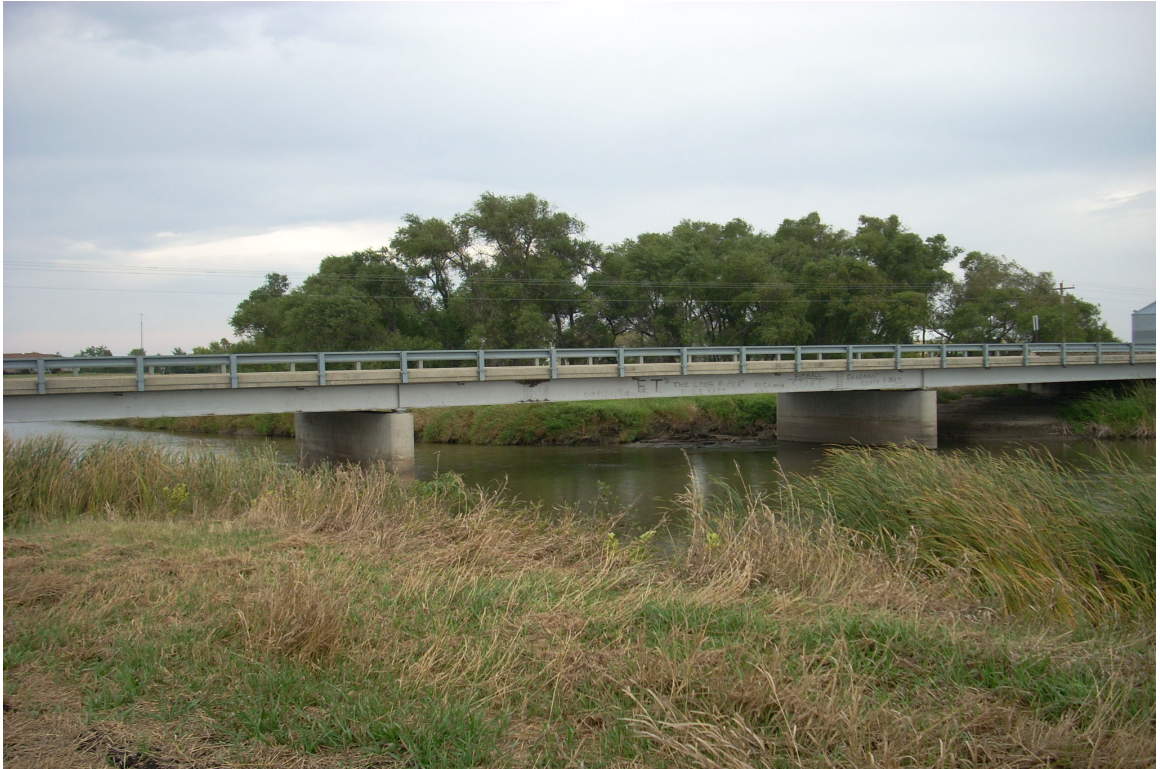
Photograph 1. Overall View of the Structure, Looking North.

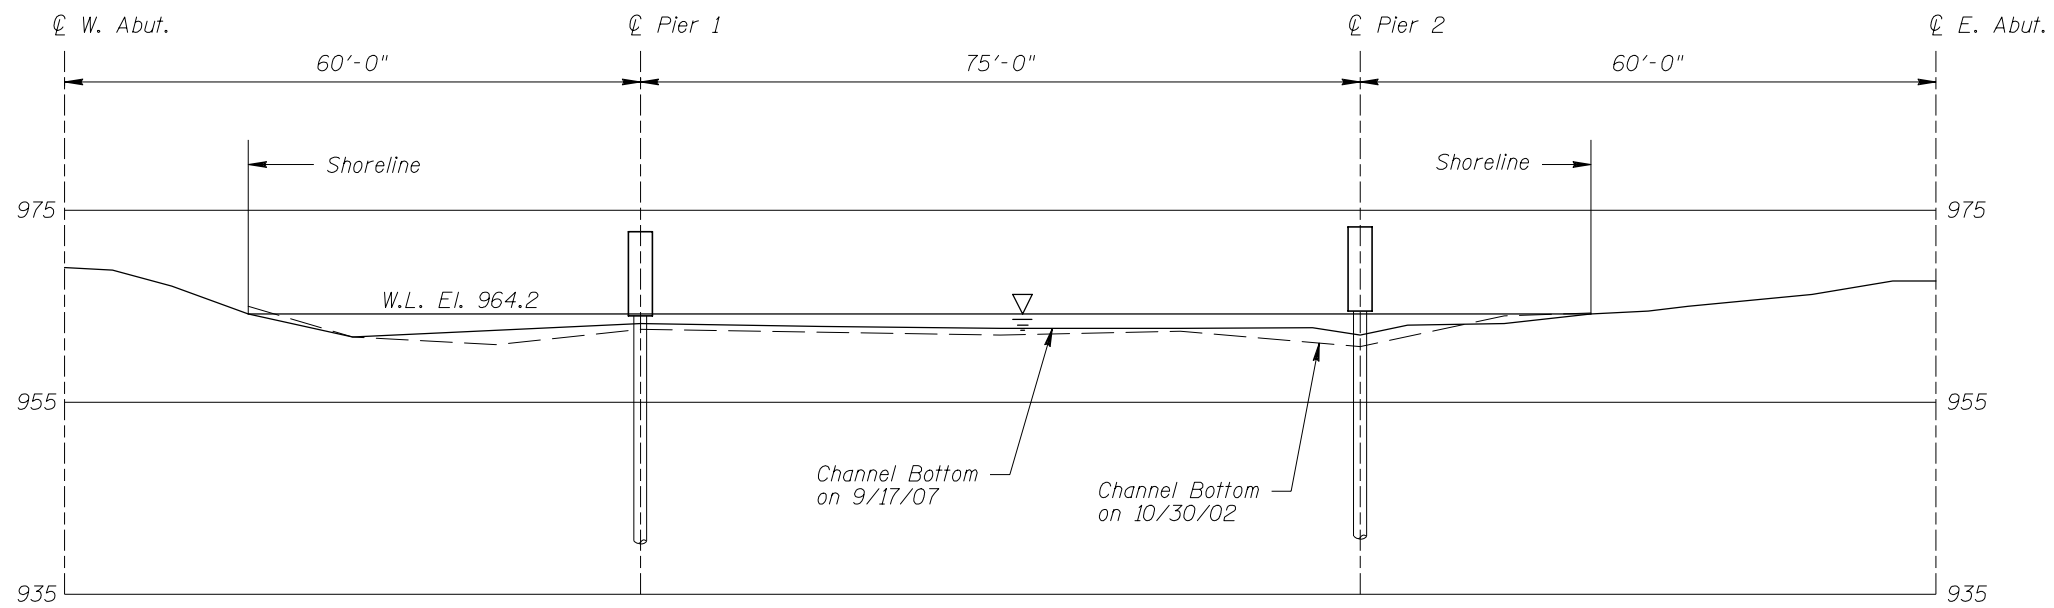
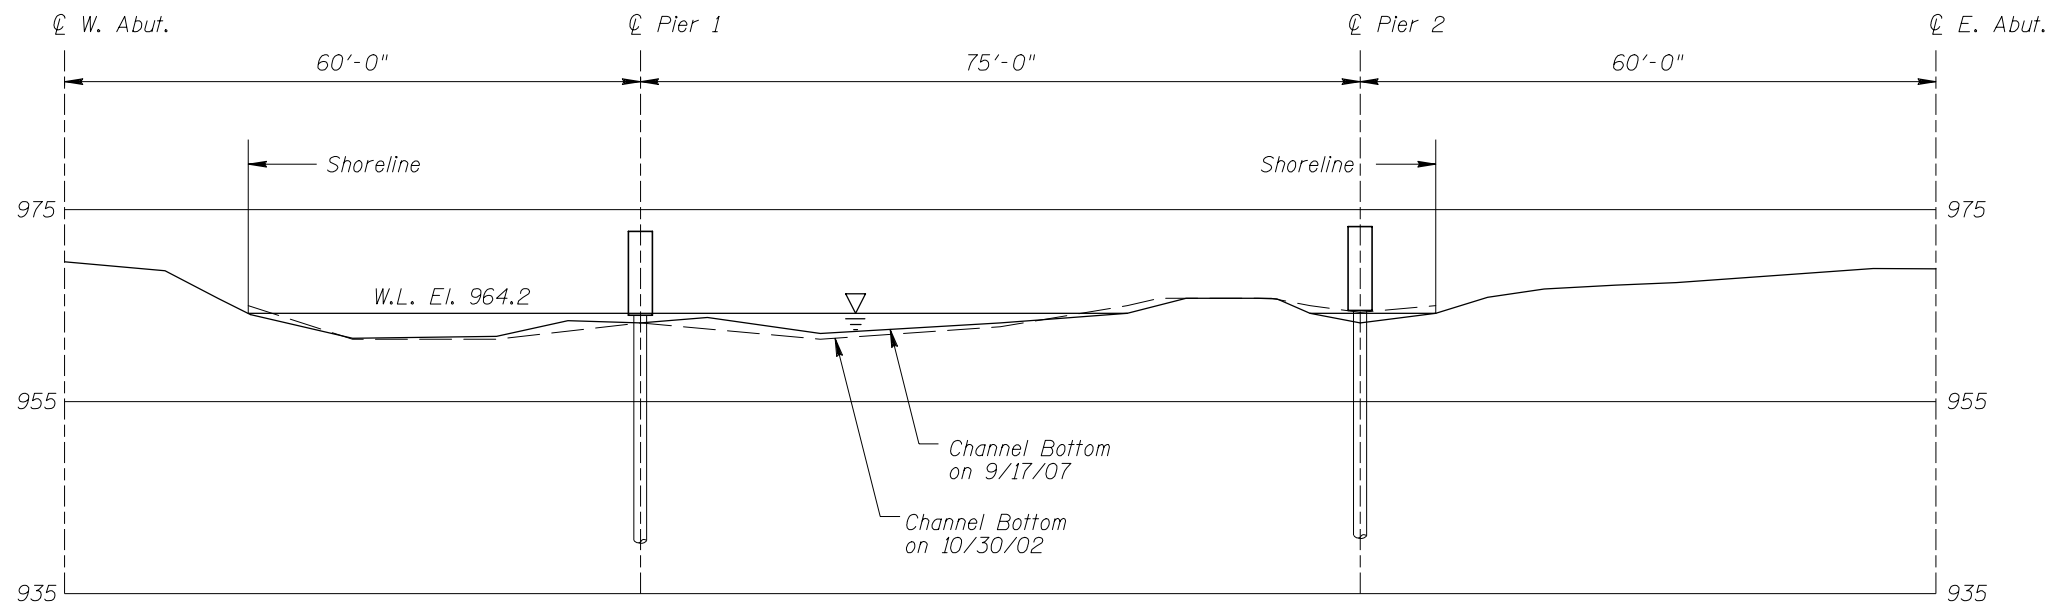
INSPECTION AND SOUNDING PLAN

1. The channel bottom consisted of silty sand with up to 12 inches of probe rod penetration.
2. A minor accumulation of branchy timber debris, with pieces up to 3 inches in diameter, along with some minor steel debris was observed on the channel bottom at the upstream end of Pier 1 and extending along the north side of the pier.

3. Minor accumulations of branchy timber debris were observed all around Pier 2 with a moderate accumulation of larger timber debris, with pieces up to 12 inches in diameter, observed at the downstream end of the pier.

4. The concrete pier cap exhibited timber formwork embedded into the south face of Pier 1 with an area of concrete section loss observed along the formwork which was 2.5 feet long, 1 foot wide, and 4 inches deep.

5. A large area of slop concrete was observed on the channel bottom along the center portion of Pier 1.
6. The west embankment was well armored with riprap up to 3 feet in diameter.

7. Scour depression 3 feet radius by 1 foot deep observed at the upstream end of Pier 2. It extended from upstream end to the downstream 1/4 point on the south side and the midpoint on the north side.

8. Scour depression 3 feet radius by 1 foot deep was observed at downstream end of Pier 1.
